NASA/TP-97-206257

The Characteristics of Fatigue Damage in the Fuselage Riveted Lap Splice Joint

Robert S. Piascik
Langley Research Center, Hampton, Virginia

November 1997

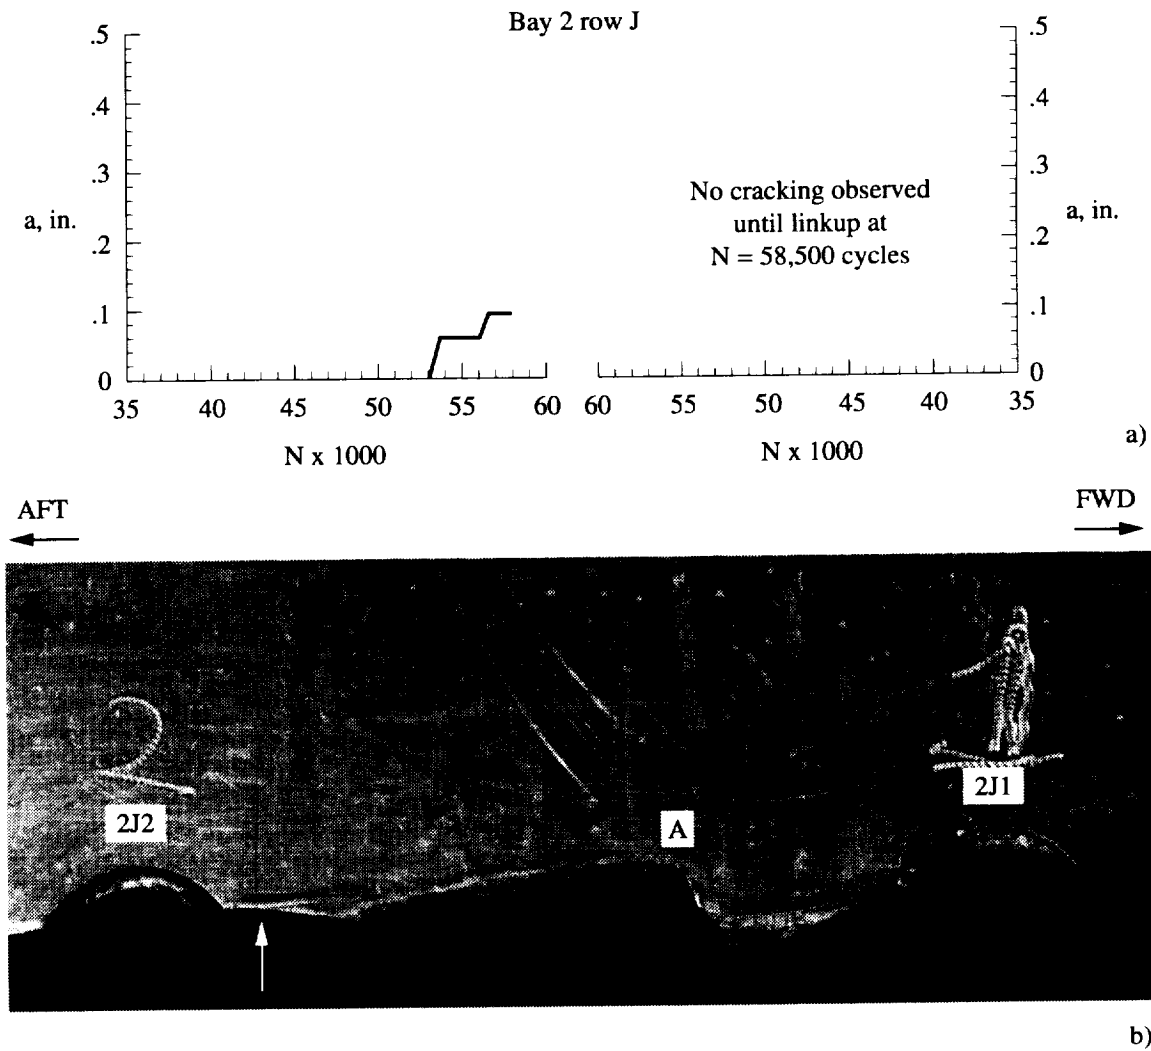
Figure 7.8 a) The figure is a plot of outer skin crack length (a) measured from the rivet outside diameter versus pressurization cycles (N). *In situ* visual crack length measurements were taken during pressure testing. Fatigue crack growth plots are shown for crack segments 2J1 aft and 2J2 forward. No visual cracks were observed from rivet hole 2J1 until after crack link-up ($N=60,000$ cycles). b) The photograph shows the upper portion of the outer skin crack surface between rivet holes 2J1 and 2J2. An arrow marks the upper portion of the outer skin crack surface. Region A is the approximate final position of the fatigue crack noted (visually) prior to crack link-up. Most of the crack surface shown in Figure 7.8.b exhibits a roughened appearance. This slant fracture region is characteristic of ductile tearing produced by relatively high crack tip stress intensity. The slant fracture region contain scratches normal to the direction of crack propagation indicative of fracture surface contact resulting from mode III displacement.

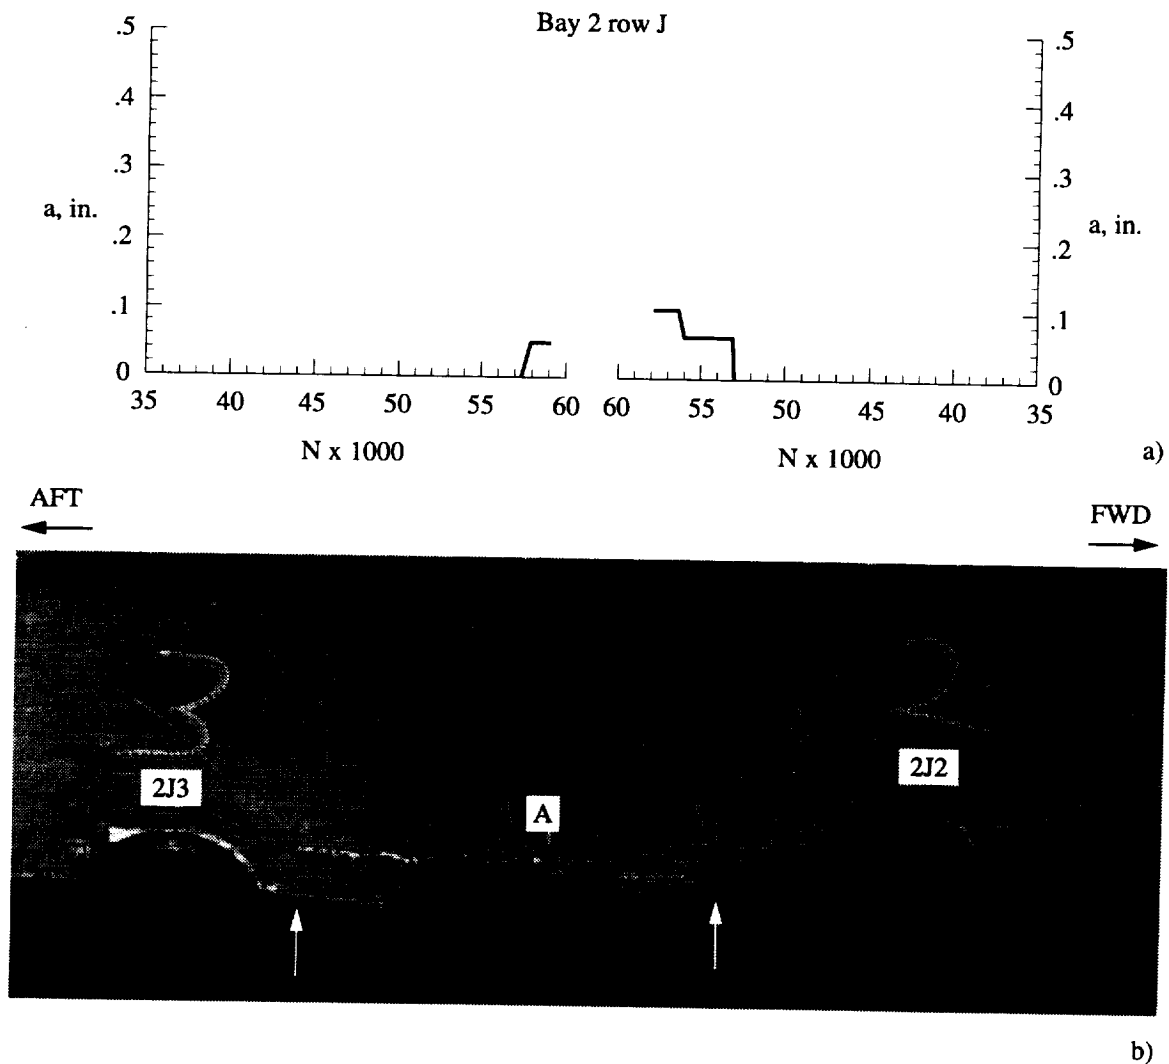
Figure 7.9 a) The figure is a plot of outer skin crack length (a) measured from the rivet outside diameter versus pressurization cycles (N). *In situ* visual crack length measurements were taken during pressure testing. Fatigue crack growth plots are shown for crack segments 2J2 aft and 2J3 forward. b) The photograph shows the upper portion of the outer skin crack surface between rivet holes 2J2 and 2J3. Arrows mark the approximate final position of the fatigue cracks noted (visually) prior to crack link-up. Region A is the likely position where both cracks linked. Most of the crack surface shown in Figure 7.9.b exhibits a roughened appearance. This slant fracture region is characteristic of ductile tearing produced by relatively high crack tip stress intensity. The slant fracture region contains scratches normal to the direction of crack propagation indicative of fracture surface contact resulting from mode III displacement.

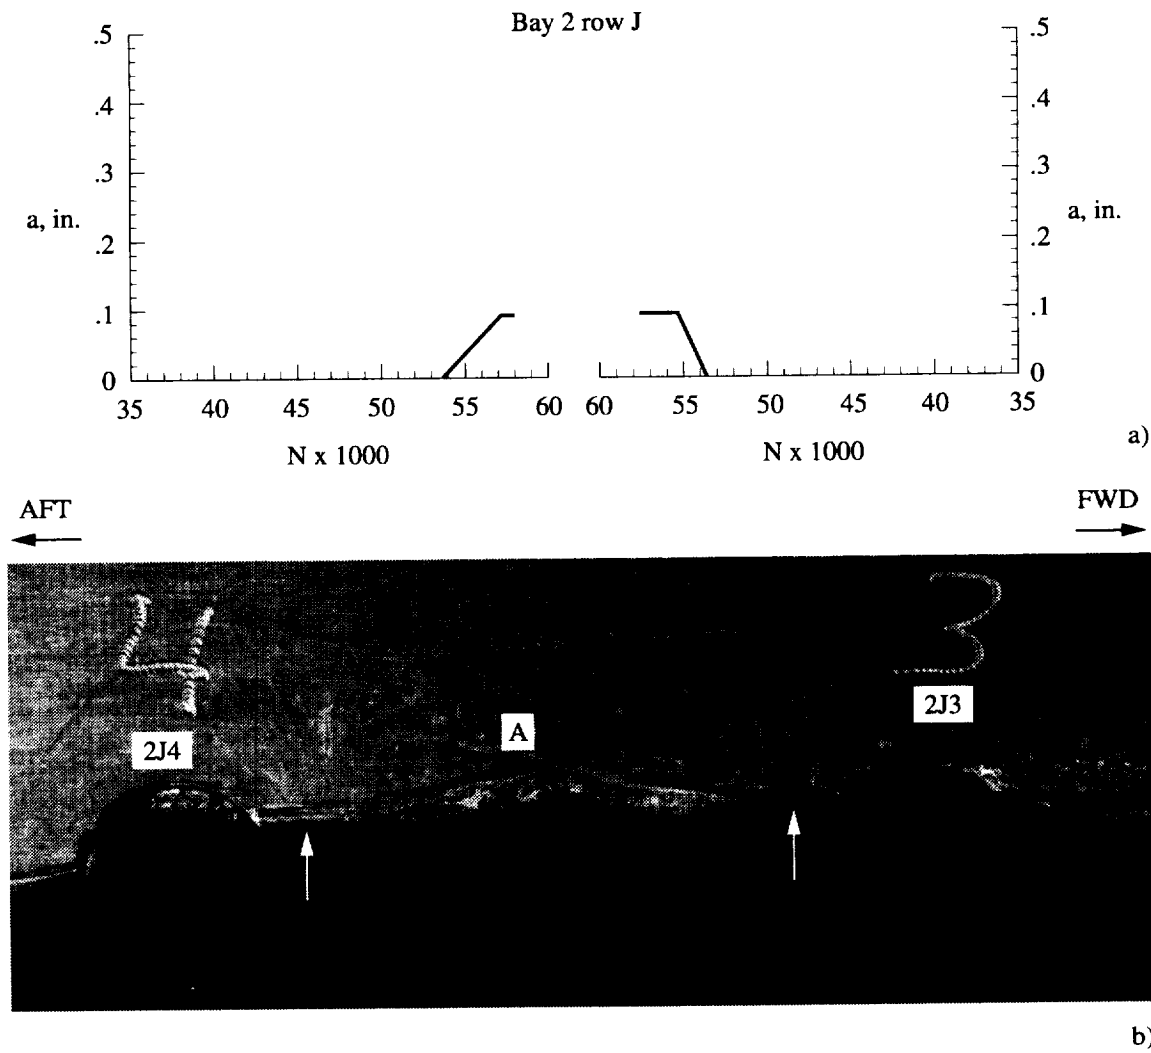
Figure 7.10 a) The figure is a plot of outer skin crack length (a) measured from the rivet outside diameter versus pressurization cycles (N). *In situ* visual crack length measurements were taken during pressure testing. Fatigue crack growth plots are shown for crack segments 2J3 aft and 2J4 forward. b) The photograph shows the upper portion of the outer skin crack surface between rivet holes 2J3 and 2J4. Arrows mark the approximate final position of the fatigue cracks noted (visually) prior to crack link-up. Region A is the likely position where both cracks linked. Most of the crack surface shown in Figure 7.10.b exhibits a roughened appearance. This slant fracture region is characteristic of ductile tearing produced by relatively high crack tip stress intensity. The slant fracture region contains scratches normal to the direction of crack propagation indicative of fracture surface contact resulting from mode III displacement.

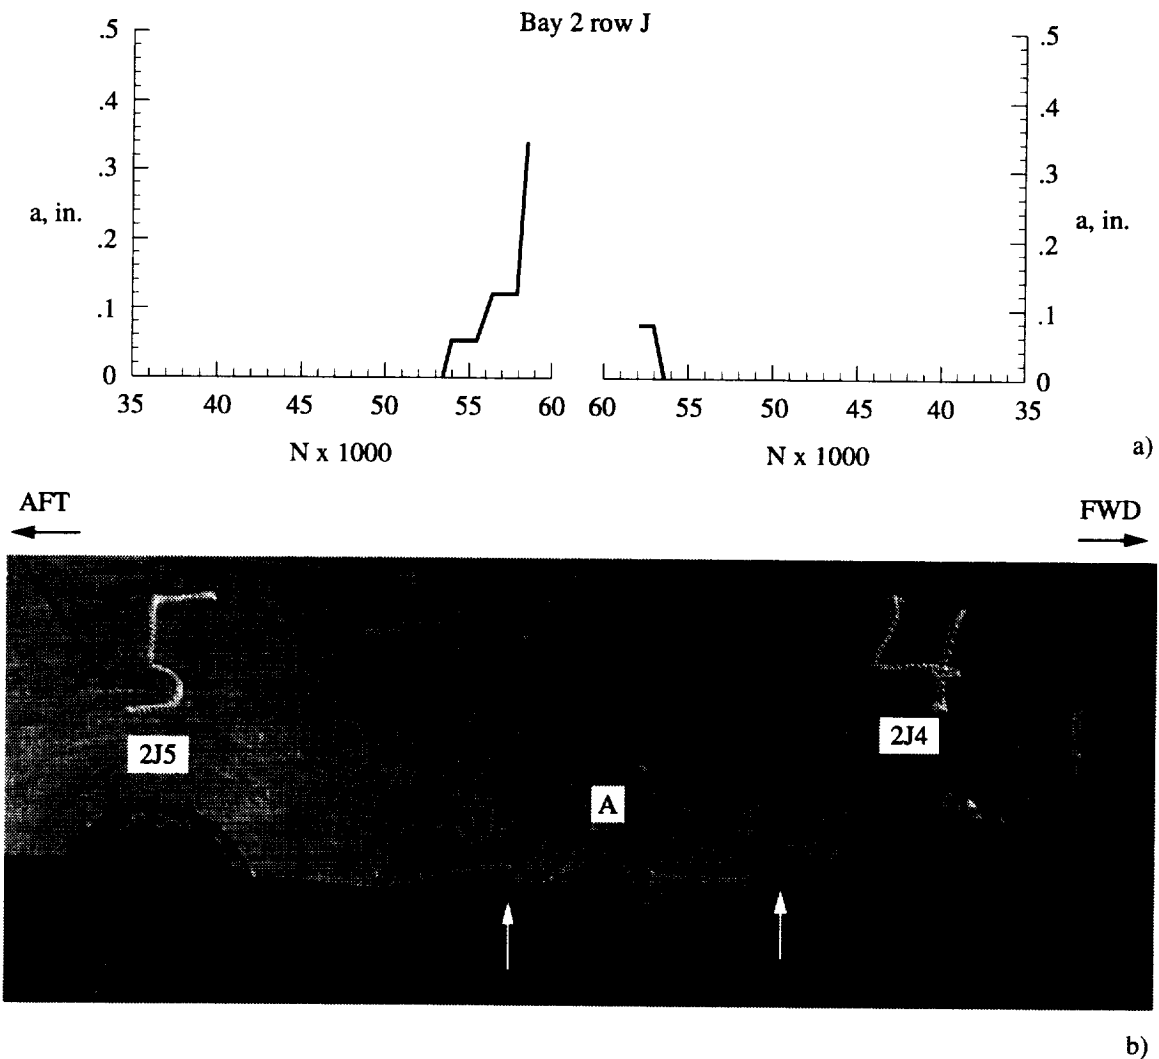
Figure 7.11 a) The figure is a plot of outer skin crack length (a) measured from the rivet outside diameter versus pressurization cycles (N). *In situ* visual crack length measurements were taken during pressure testing. Fatigue crack growth plots are shown for crack segments 2J4 aft and 2J5 forward. The plot for hole 5 shows that very rapid crack growth occurred just prior to crack link-up. b) The photograph shows the upper portion of the outer skin crack surface between rivet holes 2J4 and 2J5. Arrows mark the approximate final position of the fatigue cracks noted (visually) prior to crack link-up. Region A is the likely position where both cracks linked. Most of the crack surface shown in Figure 7.11.b exhibits a roughened appearance. This slant fracture region is characteristic of ductile tearing produced by relatively high crack tip stress intensity. The slant fracture region contains scratches normal to the direction of crack propagation indicative of fracture surface contact resulting from mode III displacement.

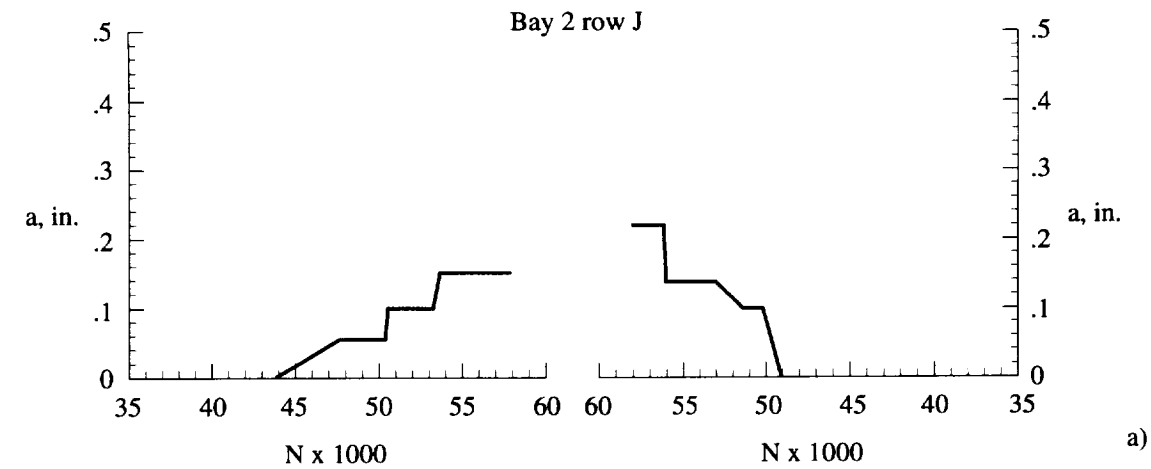
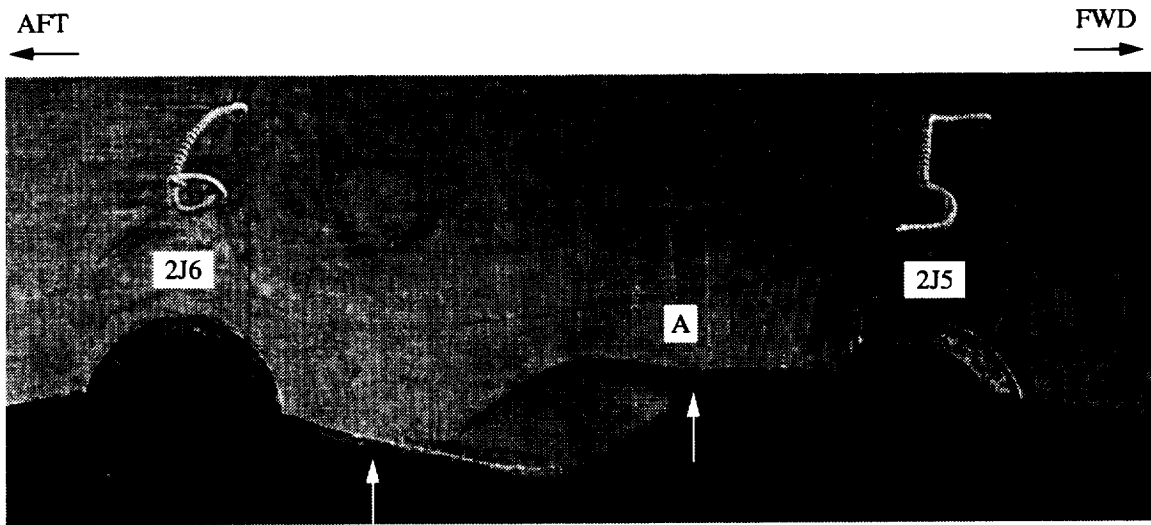
Figure 7.12 a) The figure is a plot of outer skin crack length (a) measured from the rivet outside diameter versus pressurization cycles (N). *In situ* visual crack length measurements were taken during pressure testing. Fatigue crack growth plots are shown for crack segments 2J5 aft and 2J6 forward. b) The photograph shows the upper portion of the outer skin crack surface between rivet holes 2J5 and 2J6. This region is also shown in Figure 7.7.b prior to destructive examination. Arrows mark the approximate final position of the fatigue cracks noted (visually) prior to crack link-up. Region A is the likely position where cracks from both holes had linked. Most of the crack surface shown in Figure 7.12.b exhibits a roughened appearance. This slant fracture region is characteristic of ductile tearing produced by relatively high crack tip stress intensity. The slant fracture region contains no scratches normal to the direction of crack propagation observed in other rivet hole regions. This suggests that this region was captured by the rivets and link-up occurred before large mode III displacement resulted from pillowing.

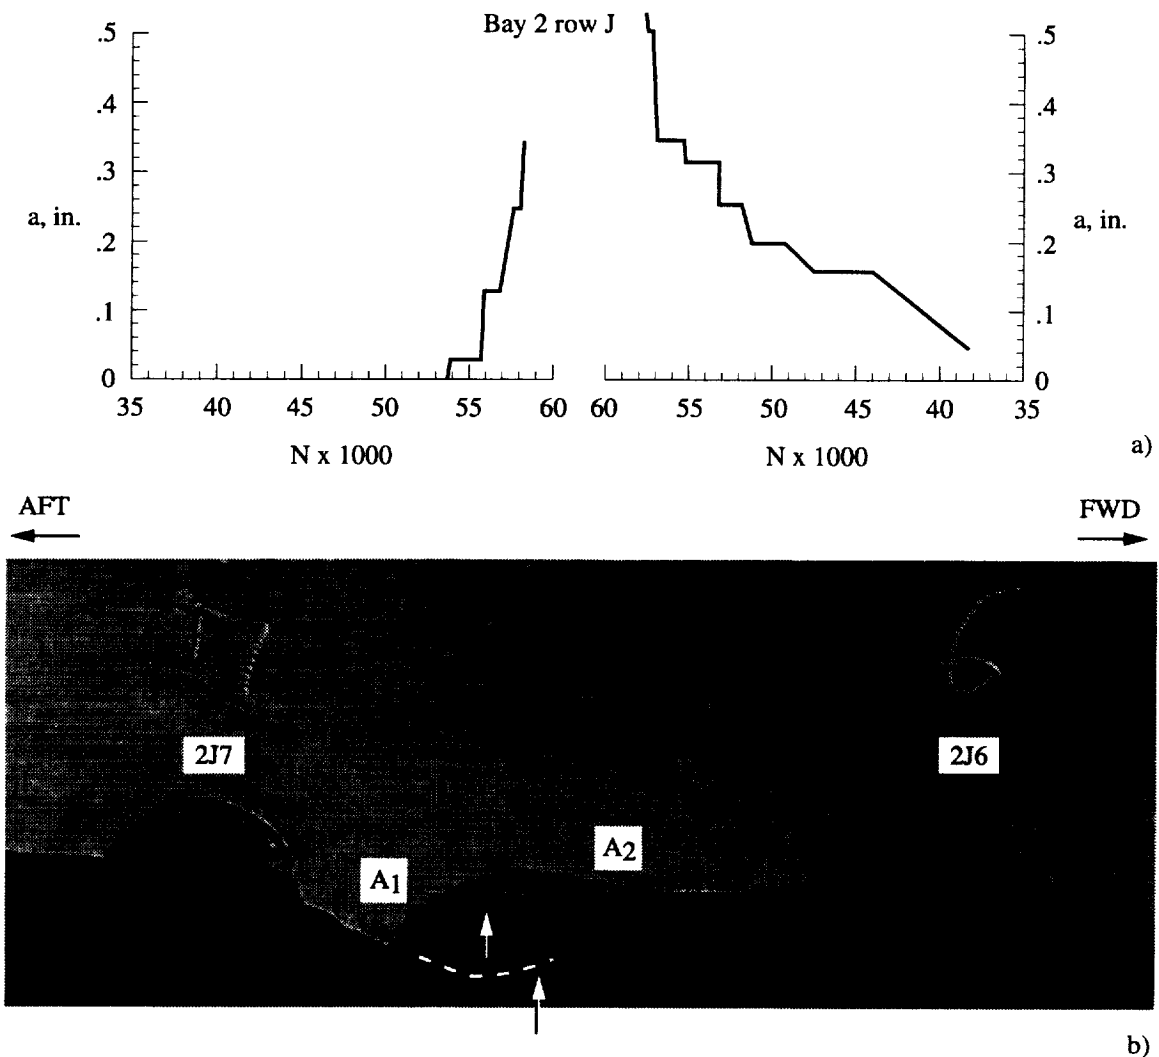
Figure 7.13 a) The figure is a plot of outer skin crack length (a) measured from the rivet outside diameter versus pressurization cycles (N). *In situ* visual crack length measurements were taken during pressure testing. Fatigue crack growth plots are shown for crack segments 2J6 aft and 2J7 forward. The plots for hole 2J6 and 2J7 show that very rapid crack growth occurred just prior to crack link-up. b) The photograph shows the upper portion of the outer skin crack surface between rivet holes 2J6 and 2J7. This region is shown in Figure 7.7.b prior to the destructive examination. Arrows mark the approximate final position of the fatigue cracks noted (visually) prior to crack link-up. Dashed lines represent the approximate path of the crack that propagated from hole 7. Regions A1 or A2 are the likely positions for crack link-up. Most of the crack surface shown in Figure 7.13.b exhibits a roughened appearance. This slant fracture region is characteristic of ductile tearing produced by relatively high crack tip stress intensity. The slant fracture region contains no scratches normal to the direction of crack propagation observed in other rivet hole regions. This suggests that this region was captured by the rivets and link-up occurred before large mode III displacement resulted from pillowing.

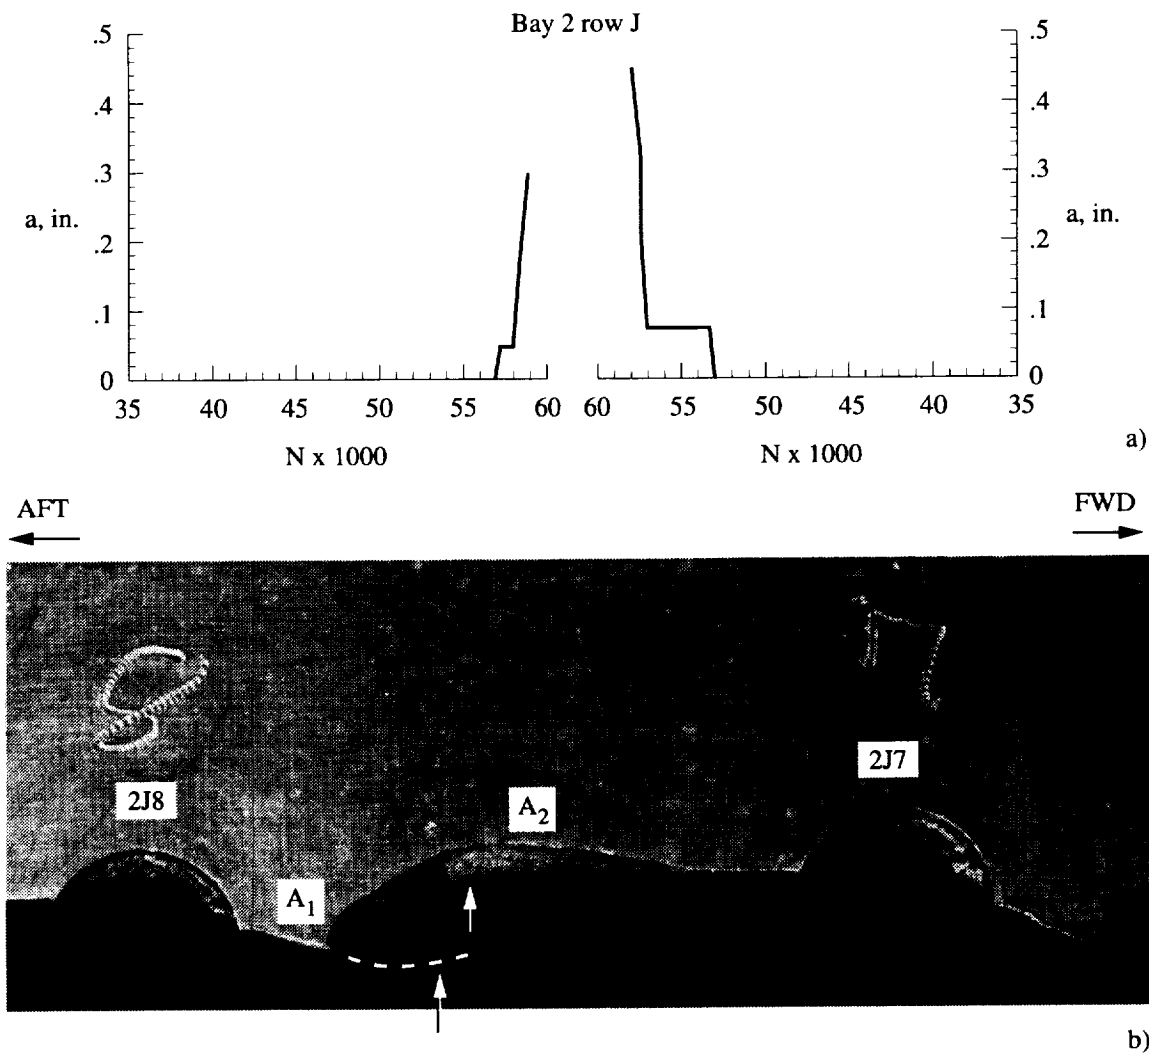
Figure 7.14 a) The figure is a plot of outer skin crack length (a) measured from the rivet outside diameter versus pressurization cycles (N). *In situ* visual crack length measurements were taken during pressure testing. Fatigue crack growth plots are shown for crack segments 2J7 aft and 2J8 forward. The plots for hole 2J7 and 2J8 show that very rapid crack growth occurred just prior to crack link-up. b) The photograph shows the upper portion of the outer skin crack surface between rivet holes 2J7 and 2J8. Arrows mark the approximate final position of the fatigue cracks noted (visually) prior to crack link-up. A dashed line represents the approximate path of the crack that propagated from hole 2J8. Regions A1 or A2 are the likely positions for crack link-up. Most of the crack surface shown in Figure 7.14.b exhibits a roughened appearance. This slant fracture region is characteristic of ductile tearing produced by relatively high crack tip stress intensity. The slant fracture region contains no scratches normal to the direction of crack propagation observed in other rivet hole regions. This suggests that this region was captured by the rivets and link-up occurred before large mode III displacement resulted from pillowng.

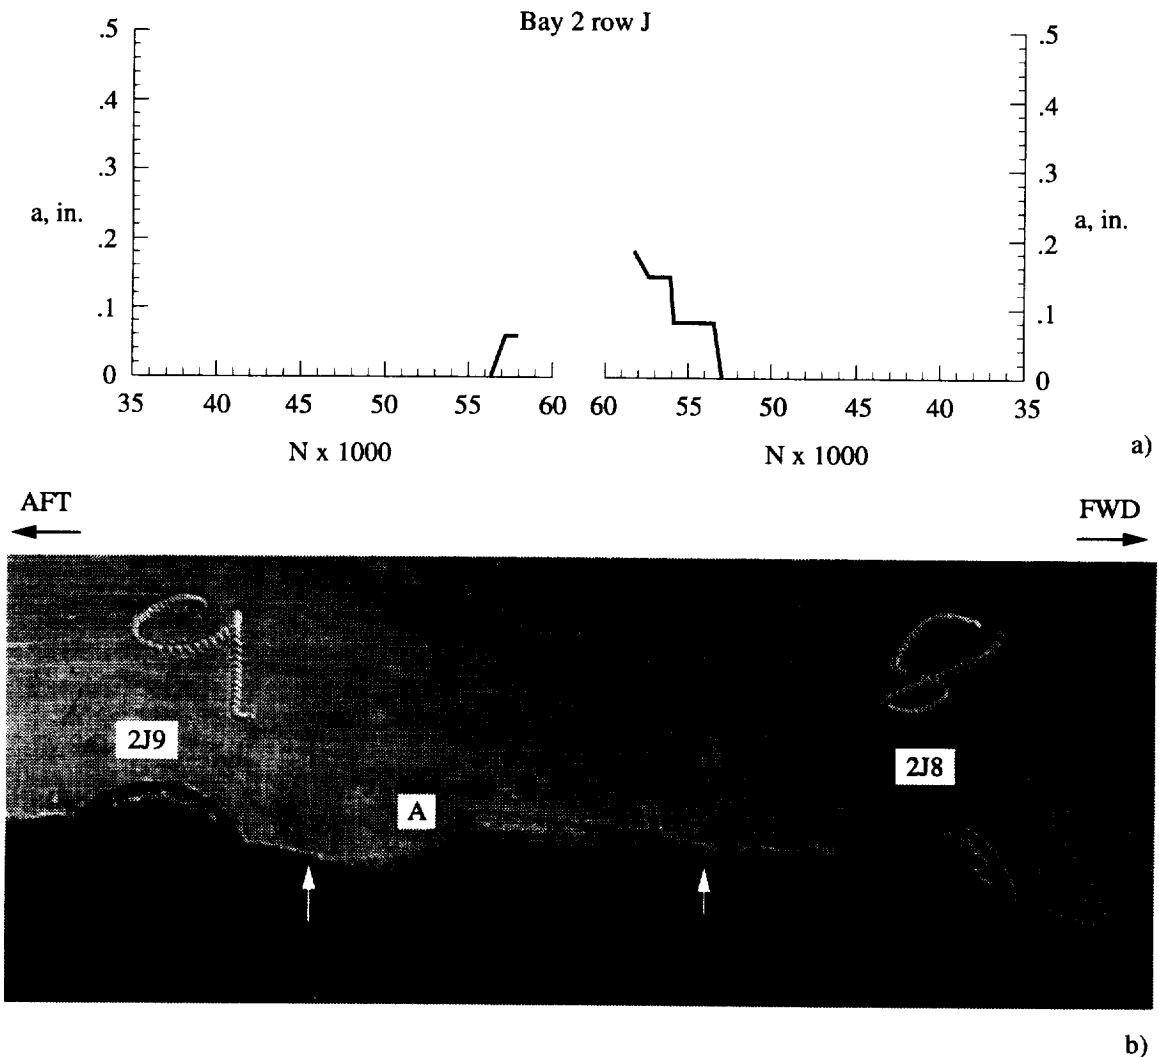
Figure 7.15 a) The figure is a plot of outer skin crack length (a) measured from the rivet outside diameter versus pressurization cycles (N). *In situ* visual crack length measurements were taken during pressure testing. Fatigue crack growth plots are shown for crack segments 2J8 aft and 2J9 forward. b) The photograph shows the upper portion of the outer skin crack surface between rivet holes 2J8 and 2J9. Arrows mark the approximate final position of the fatigue cracks (noted visually) prior to crack link-up. Region A is the location where both cracks had linked. Most of the crack surface shown in Figure 7.15.b exhibits a roughened appearance. This slant fracture region is characteristic of ductile tearing produced by relatively high crack tip stress intensity. The slant fracture region contains scratches normal to the direction of crack propagation indicative of fracture surface contact resulting from mode III displacement.

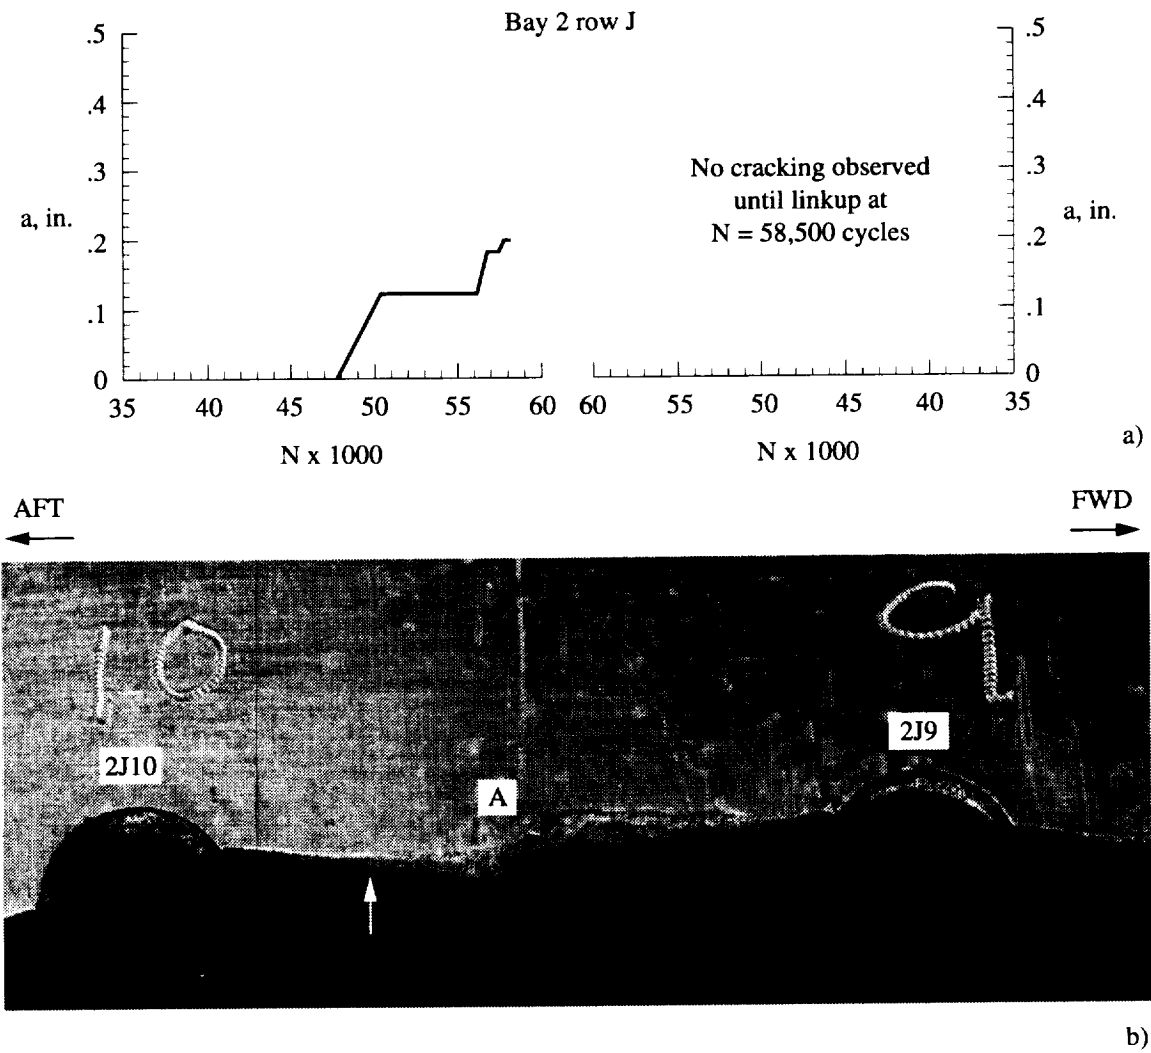
Figure 7.16 a) The figure is a plot of outer skin crack length (a) measured from the rivet outside diameter versus pressurization cycles (N). *In situ* visual crack length measurements were taken during pressure testing. Fatigue crack growth plots are shown for crack segments 2J9 aft and 2J10 forward. No visible cracks were observed from rivet hole 2J9 until after crack link-up. b) The photograph shows the upper portion of the outer skin crack surface between rivet holes 2J9 and 2J10. The arrow marks the approximate final position of the fatigue crack (noted visually) prior to crack link-up. Region A is the location where both cracks had linked. Most of the crack surface shown in Figure 7.16.b exhibits a roughened appearance. This slant fracture region is characteristic of ductile tearing produced by relatively high crack tip stress intensity. The slant fracture region contains scratches normal to the direction of crack propagation indicative of fracture surface contact resulting from mode III displacement.

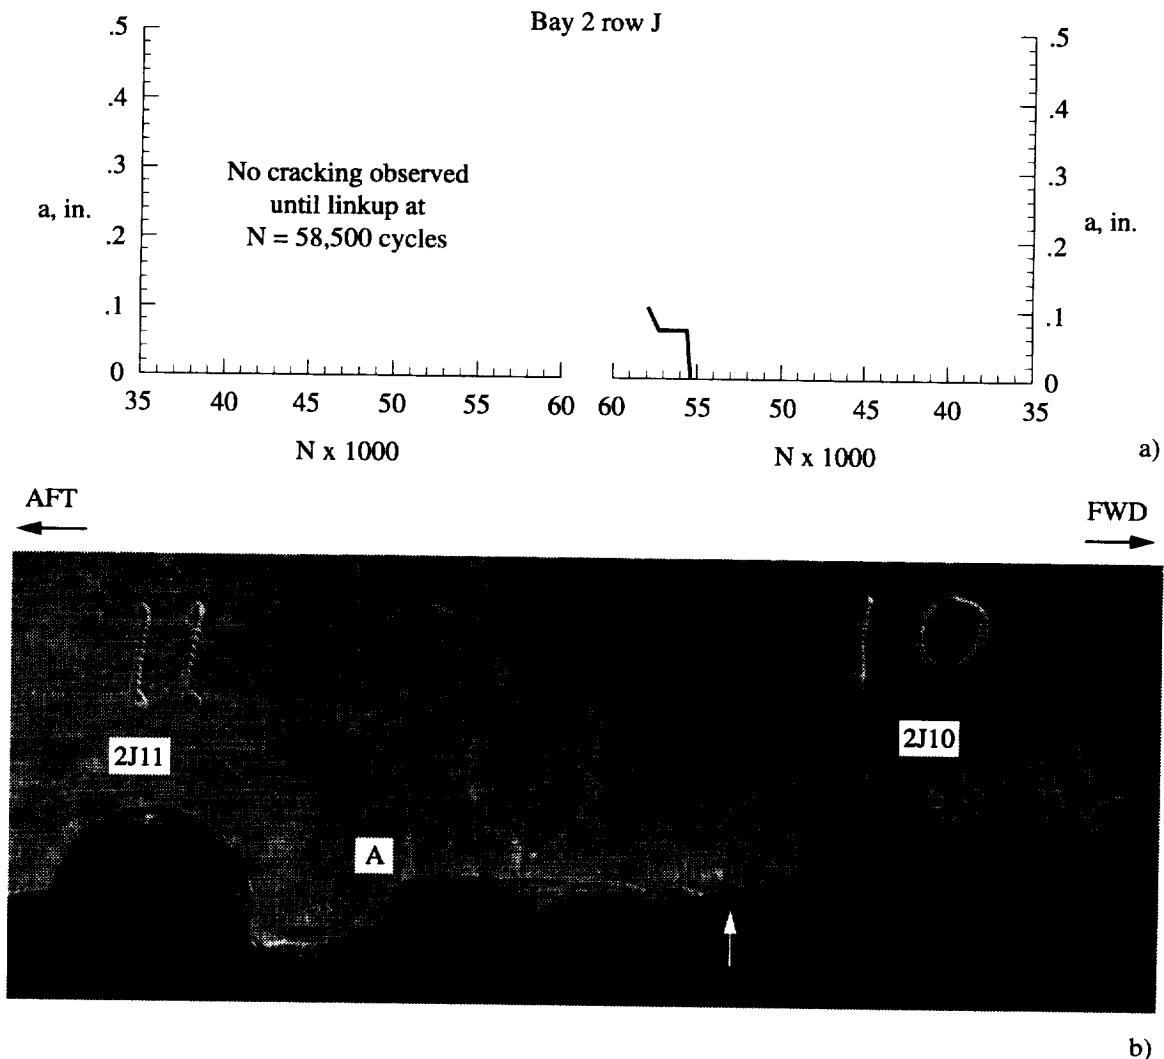
Figure 7.17 a) The figure is a plot of outer skin crack length (a) measured from the rivet outside diameter versus pressurization cycles (N). *In situ* visual crack length measurements were taken during pressure testing. Fatigue crack growth plots are shown for crack segments 2J10 aft and 2J11 forward. No visible cracks were observed from rivet hole 2J11 until after crack link-up. b) The photograph shows the upper portion of the outer skin crack surface between rivet holes 2J10 and 2J11. An arrow marks the approximate final position of the fatigue crack (noted visually) prior to crack link-up. Region A is the location where both cracks had linked. Most of the crack surface shown in Figure 7.17.b exhibits a roughened appearance. This slant fracture region is characteristic of ductile tearing produced by relatively high crack tip stress intensity. The slant fracture region contains scratches normal to the direction of crack propagation indicative of fracture surface contact resulting from mode III displacement.

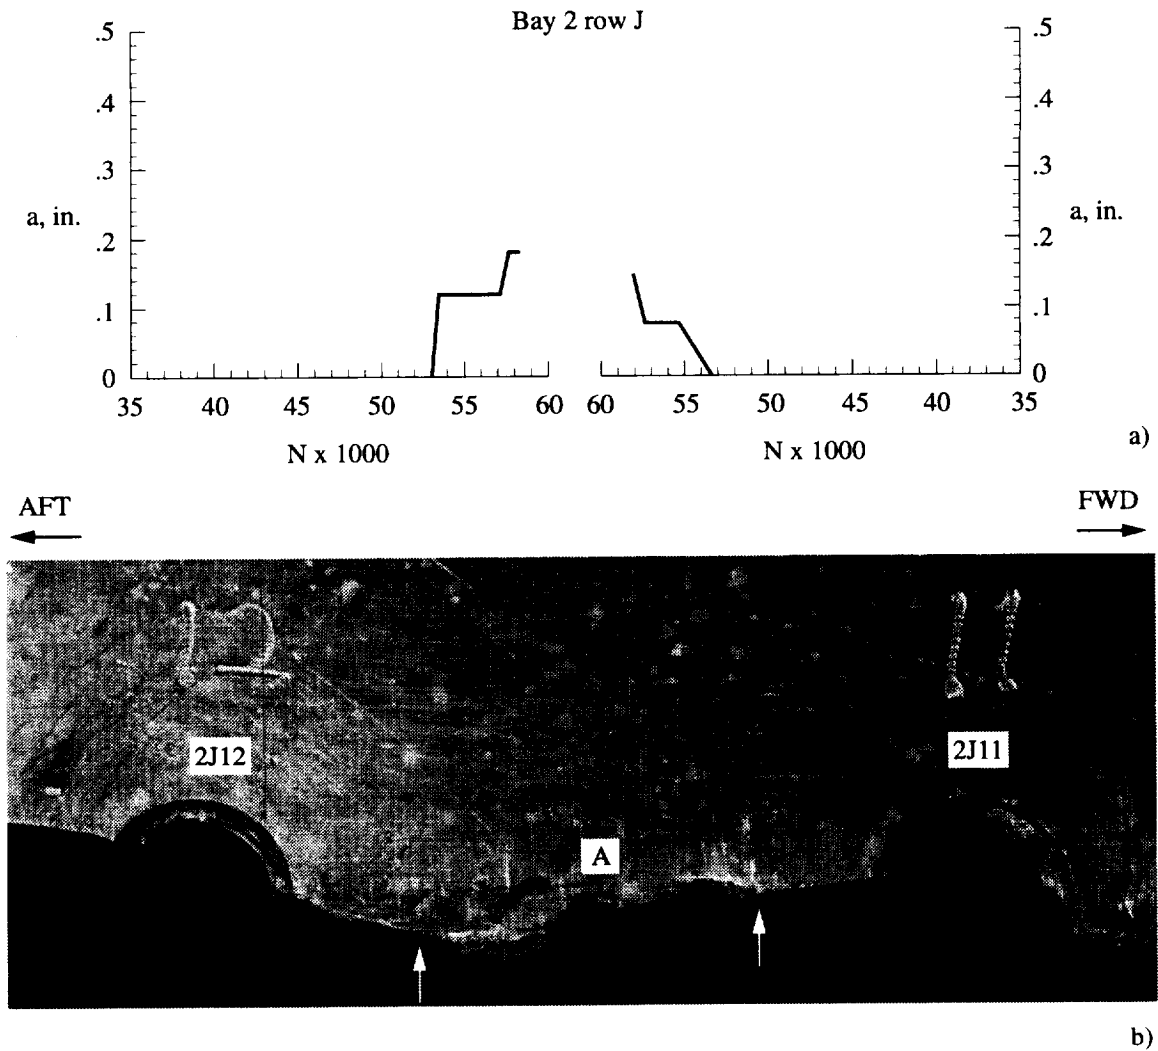
Figure 7.18 a) The figure is a plot of outer skin crack length (a) measured from the rivet outside diameter versus pressurization cycles (N). *In situ* visual crack length measurements were taken during pressure testing. Fatigue crack growth plots are shown for crack segments 2J11 aft and 2J12 forward. b) The photograph shows the upper portion of the outer skin crack surface between rivet holes 2J11 and 2J12. Arrows mark the approximate final position of the fatigue cracks (noted visually) prior to crack link-up. Region A is the location where both cracks had linked. Most of the crack surface shown in Figure 7.18.b exhibits a roughened appearance. This slant fracture region is characteristic of ductile tearing produced by relatively high crack tip stress intensity. The slant fracture region contains scratches normal to the direction of crack propagation indicative of fracture surface contact resulting from mode III displacement.

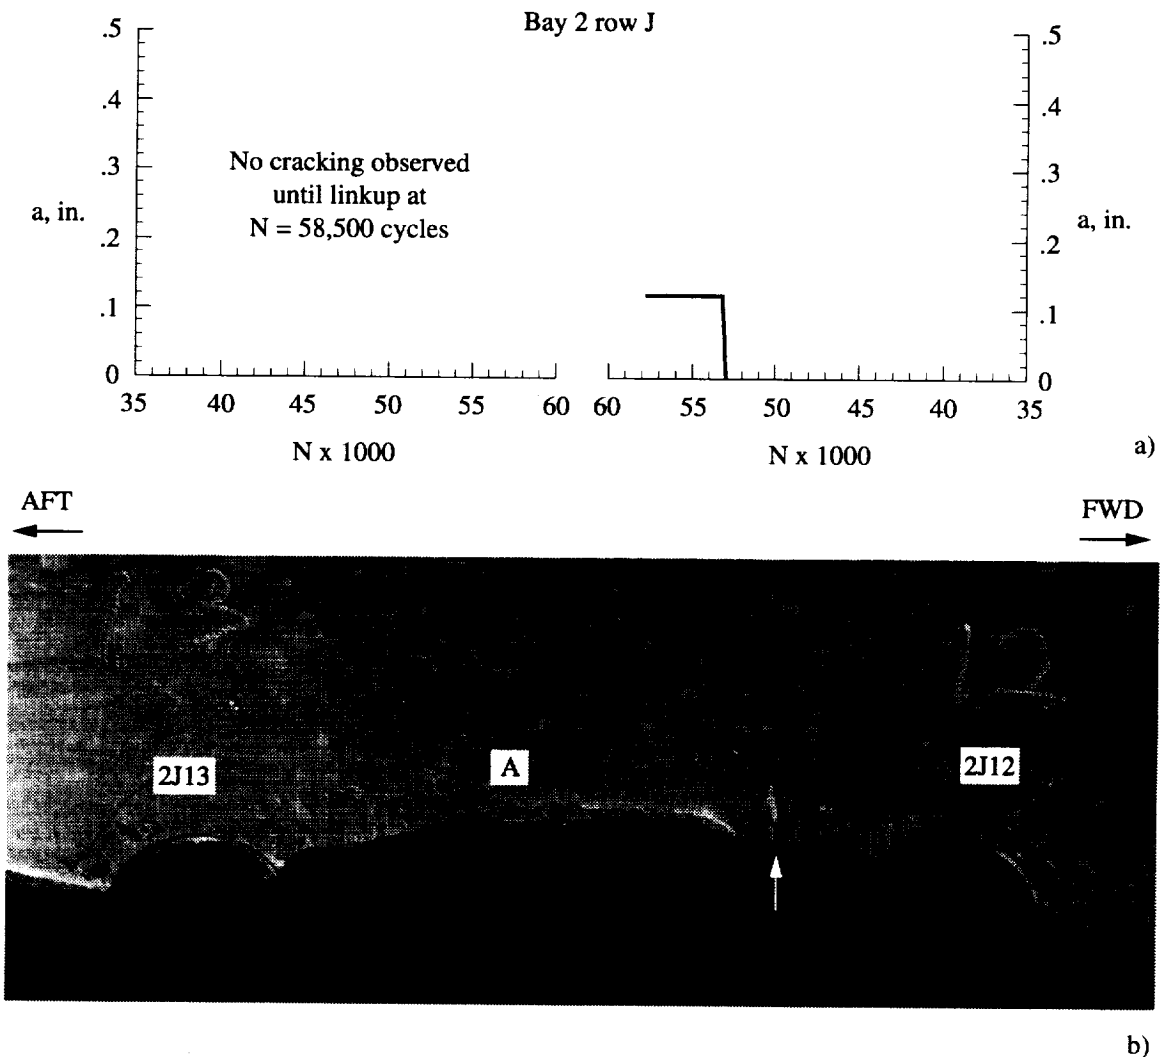
Figure 7.19 a) The figure is a plot of outer skin crack length (a) measured from the rivet outside diameter versus pressurization cycles (N). *In situ* visual crack length measurements were taken during pressure testing. Fatigue crack growth plots are shown for crack segments 2J12 aft and 2J13 forward. No visible cracks were observed from rivet hole 2J13 until after crack link-up. b) The photograph shows the upper portion of the outer skin crack surface between rivet holes 2J12 and 2J13. The arrow marks the approximate final position of the fatigue crack (noted visually) prior to crack link-up. Region A is the likely location for crack link-up. Most of the crack surface shown in Figure 7.19.b exhibits a roughened appearance. This slant fracture region is characteristic of ductile tearing produced by relatively high crack tip stress intensity. The slant fracture region contains scratches normal to the direction of crack propagation indicative of fracture surface contact resulting from mode III displacement.

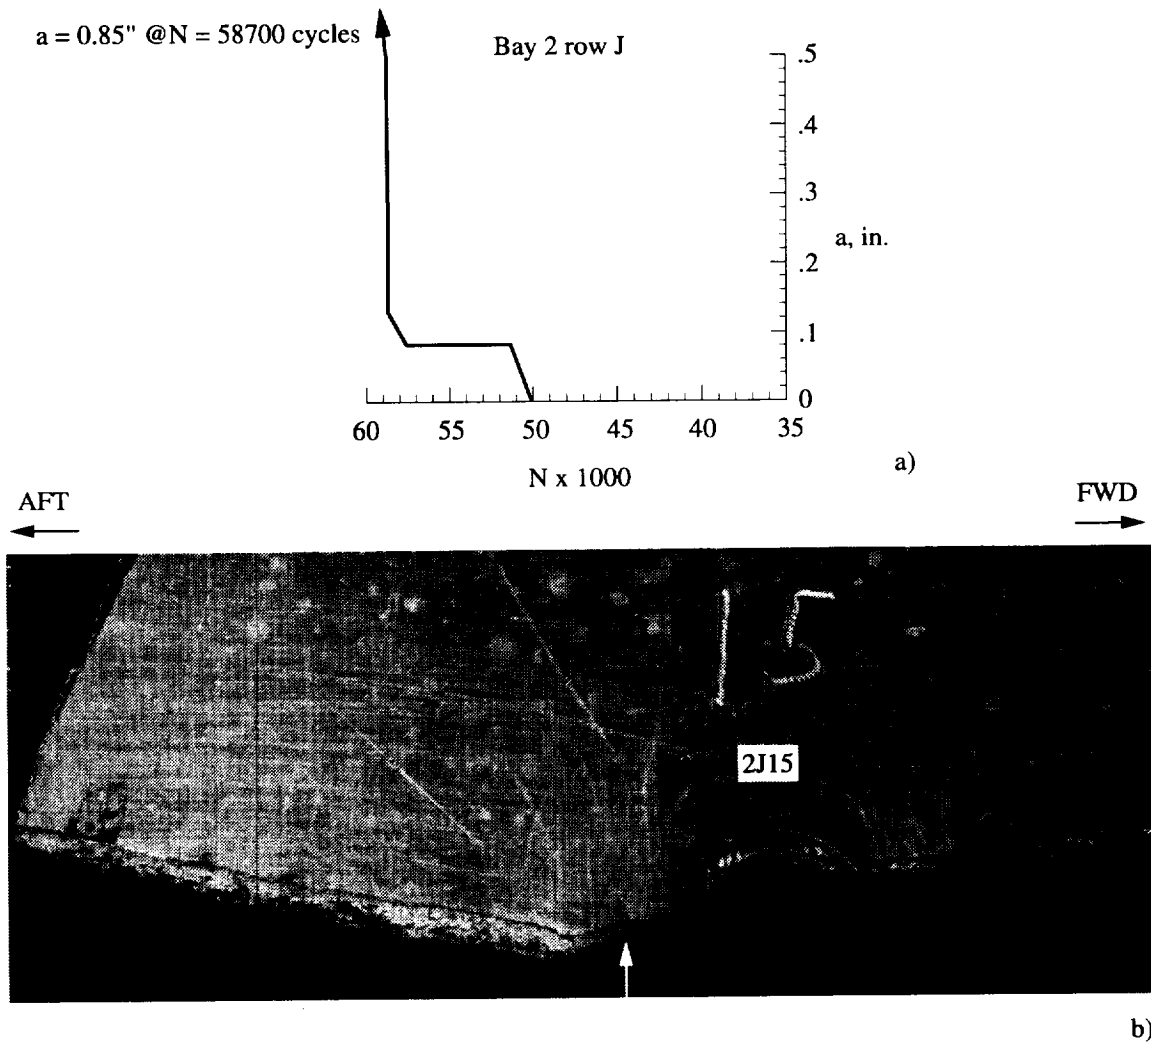
Figure 7.22 a) The figure is a plot of outer skin crack length (a) measured from the rivet outside diameter versus pressurization cycles (N). *In situ* visual crack length measurements were taken during pressure testing. The plot shown for crack segments 2J4 aft reveals that crack growth was very rapid prior to terminating in the tear strap region. b) The photograph shows the upper portion of the outer skin crack surface from hole 2J15. The arrow marks the approximate final position of the fatigue crack (noted visually) prior to crack link-up. Most of the crack surface shown in Figure 7.22.b exhibits a roughened appearance. This slant fracture region is characteristic of ductile tearing produced by relatively high crack tip stress intensity. The slant fracture region contains scratches normal to the direction of crack propagation indicative of fracture surface contact resulting from mode III displacement.

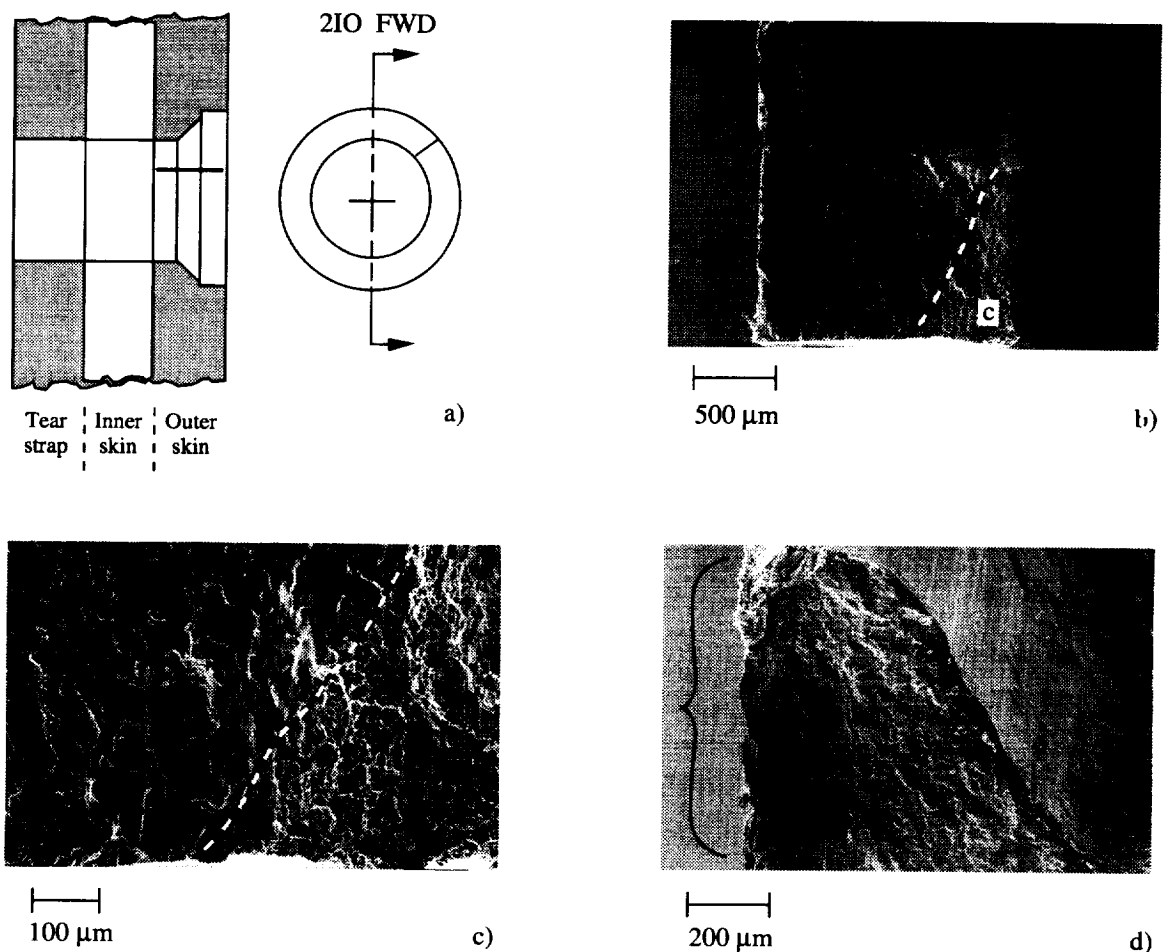
Figure 7.23 a) The schematic shows the rivet hole 2IO configuration and the location of the outer skin fatigue crack oriented in the forward direction and about the 2 o'clock position. b) The SEM micrograph shows a portion of the fatigue crack and the rivet hole (top of the micrograph). The dashed line marks a portion of the fatigue crack front. The missing portion of the fracture surface was inadvertently cut during the destructive examination. c) The SEM micrograph shows the crack front region (region "c" in Figure 7.23.b), comparing the smooth transgranular fatigue crack morphology to the rough dimpled ductile tearing of the overload fracture surface (the dashed boundary line marks the fatigue crack front and overload regions) produced during destructive examination of the rivet hole. d) The SEM micrograph shows the fatigue fracture surface at the rivet hole shank region. The bracket marks the likely region of crack initiation along the faying surface.

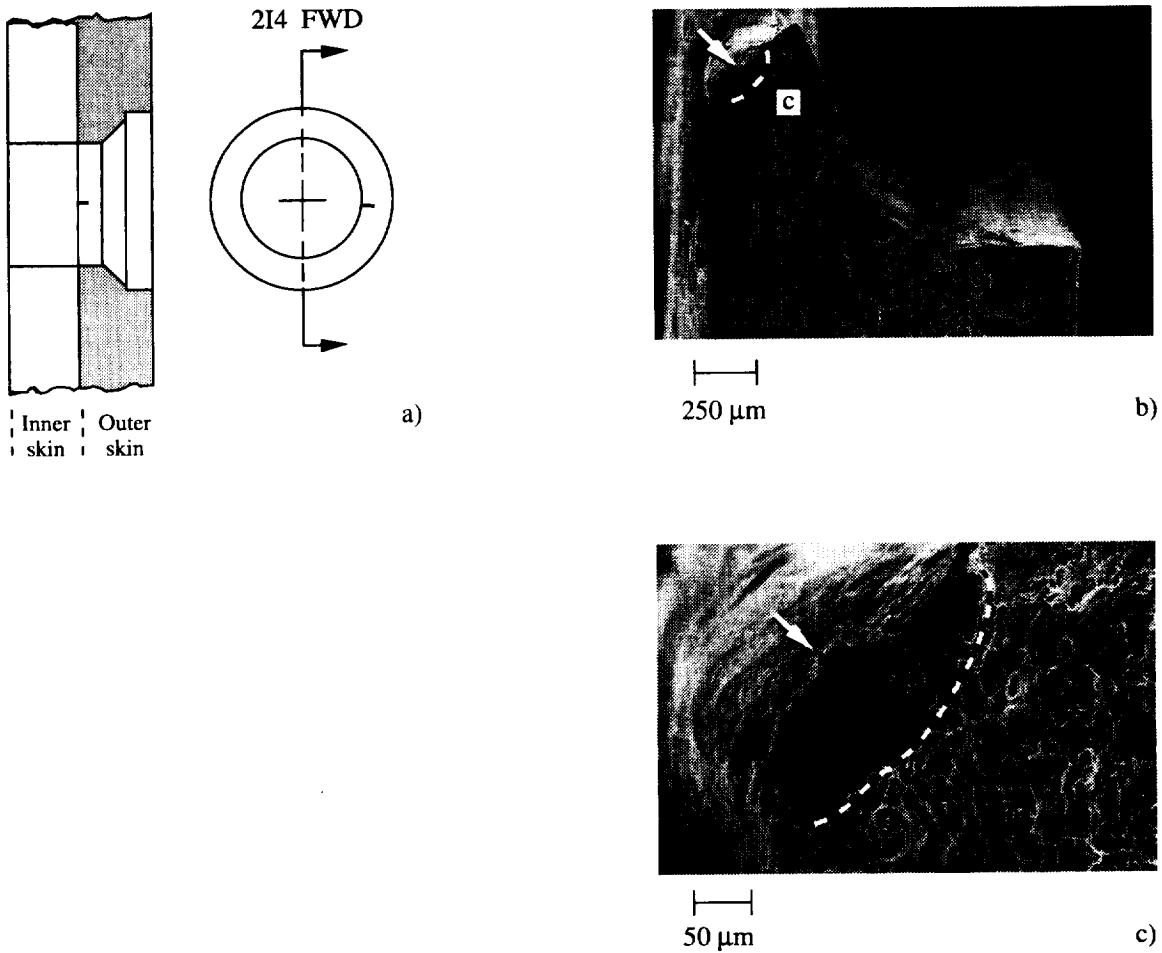
Figure 7.24 a) The schematic shows the rivet hole 2I4 configuration and the location of the outer skin fatigue crack oriented in the forward direction and about the 3 o'clock position. b) The SEM micrograph shows a small fatigue crack at the rivet hole corner marked by an arrow. c) The SEM micrograph shows the fatigue crack in Figure 7.24.b at higher magnification.
